AUCKLAND RAIL NETWORK HIGH LEVEL INFRASTRUCTURE REVIEW

Interim Findings and Assurance Report

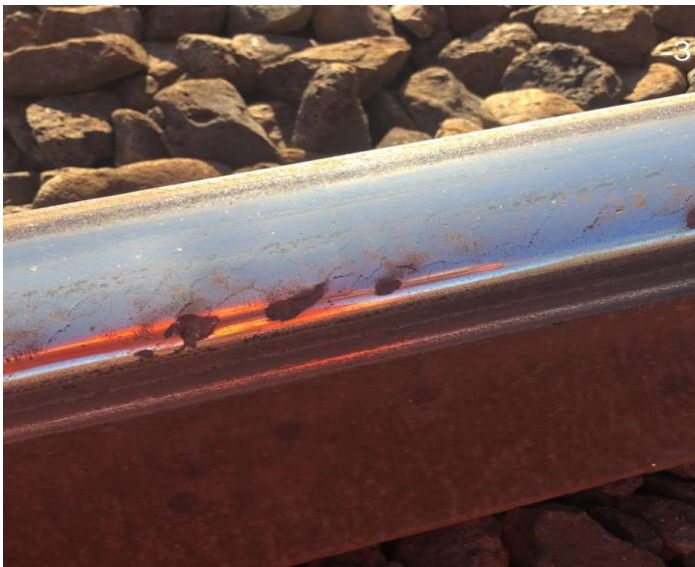
Rolling Contact Fatigue

There are a number of locations where rails are suffering from Rolling Contact Fatigue (RCF) resulting in Gauge Corner Cracking (GCC) and shelling of rail material.

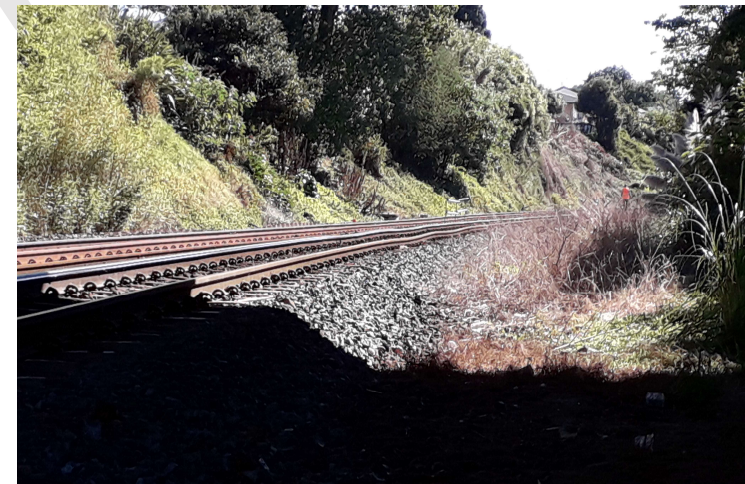
Poor track geometry due to Formation and Drainage issues

In a number of locations, deterioration of the track bed, ballast and support components (sleepers and fastenings) has resulted in track geometry misalignments, cyclic top faults and twist faults.

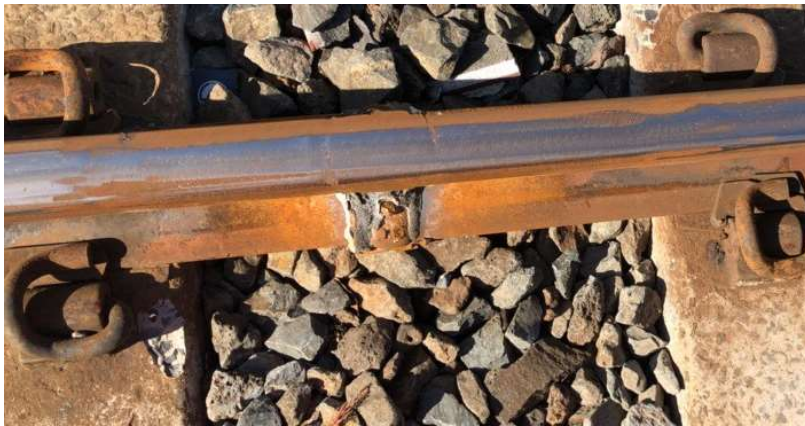
Poor track welds

There are a number of track welds which have been poorly formed because the set-up of the rails during welding or the final grinding has been incorrect due to lack of competency of welding teams.

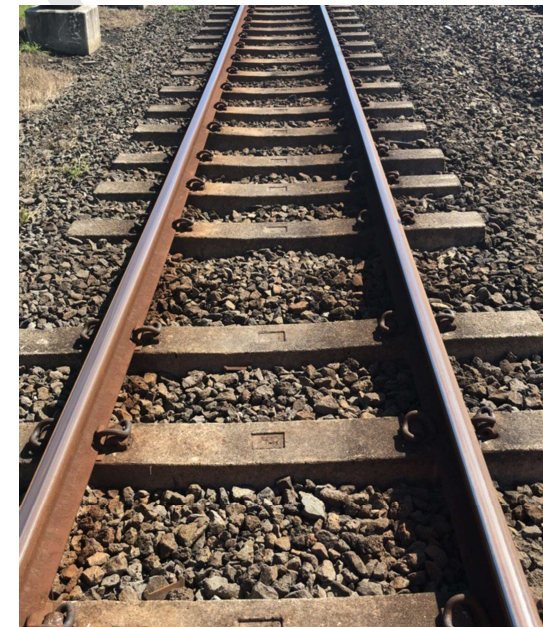
Susceptibility for track buckles

There appear to have been a number of track buckles due to an insufficient stressing regime or exacerbated by voiding under the track or deficiency of ballast in ballast shoulders and cribs.

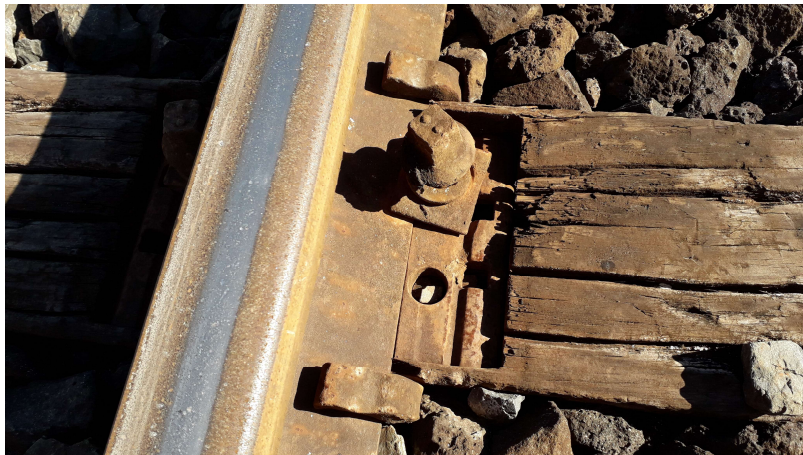
Loose fastenings

In some areas there are lengths of track with loose fastenings within poor condition wooden-sleepered tracks. In addition, in some track sections the Pandrol fastenings are loose resulting in an insufficient toe load.

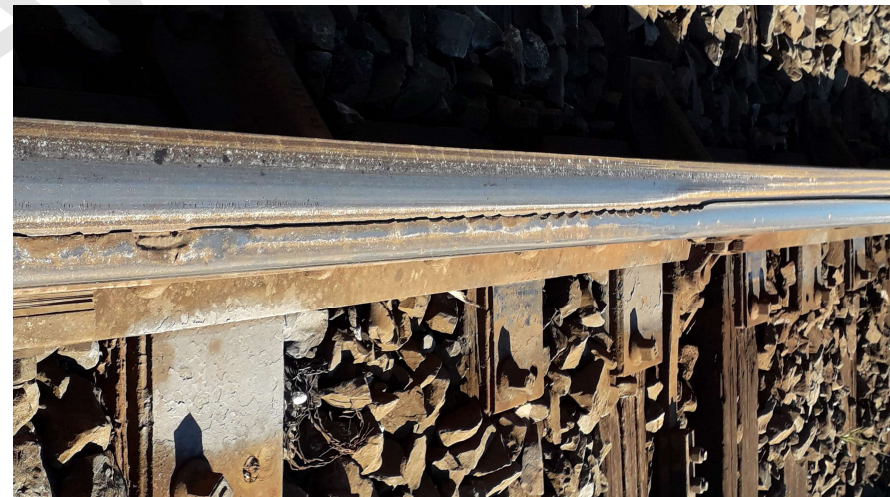
Rail Defects

A number of rail defects have been observed during the site visits. These include defects due to heavy point loads or sudden change in head plane level under traffic (head shattering or excessive wear), mushrooming of the rail head and lipping causing gauge issues and switch blade wear

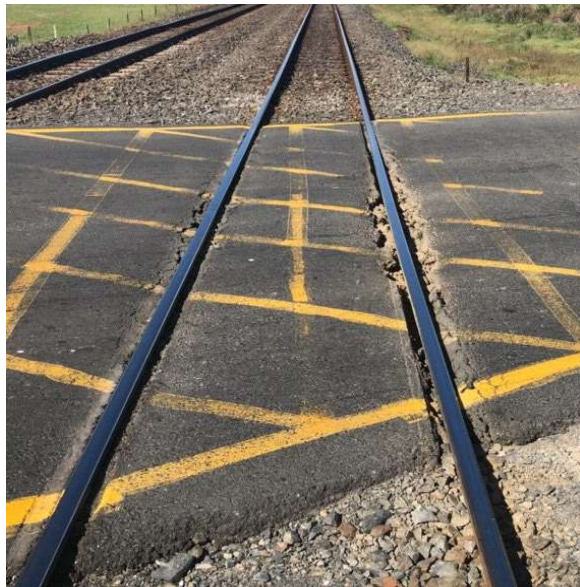
Level Crossing condition

There are a number of level crossings where the surface has been covered in tarmacadam making it difficult to assess the condition of the underlying track components.

There are several level crossings which are surfaced using tarmacadam which hides the track materials and makes it difficult to inspect and maintain the track asset. The tarmacadam should be replaced with removeable units.

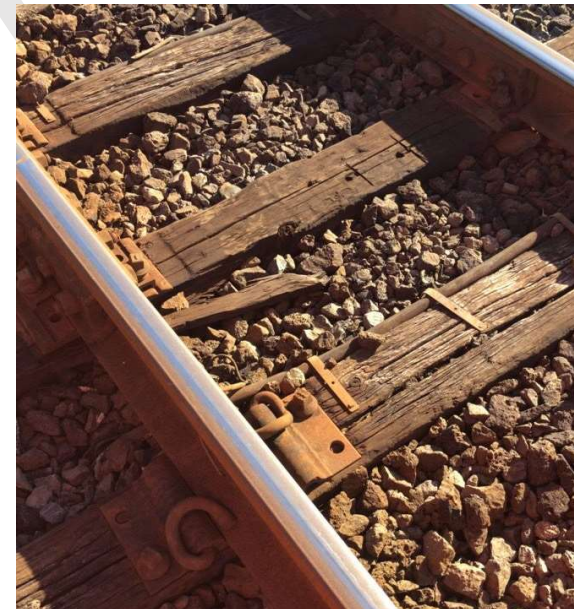
Volume of life-expired assets

There is a large volume of 91lb rail and a large number of Peruvian Decayed Sleepers on the network which are being removed under an accelerated programme

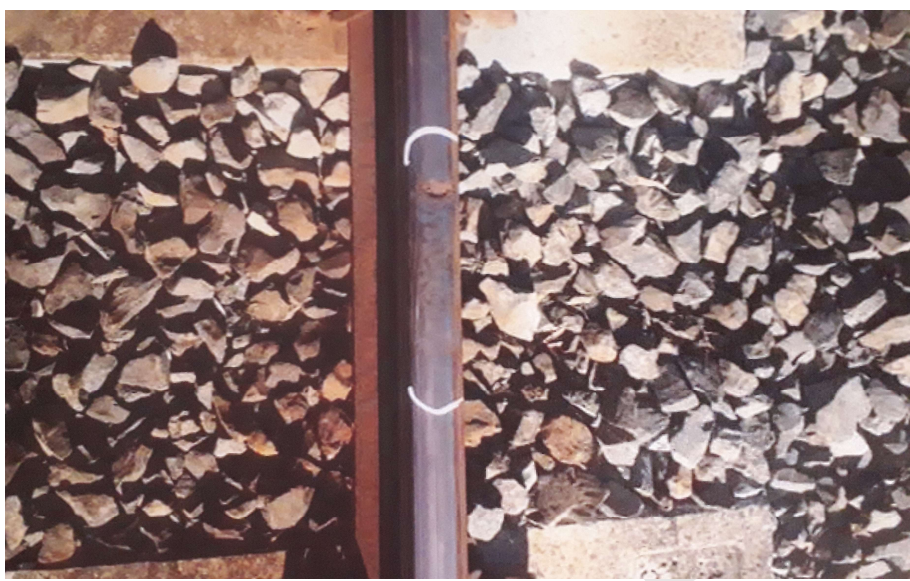
Before

Correction of surface rail defect

Assessed Condition Code 4

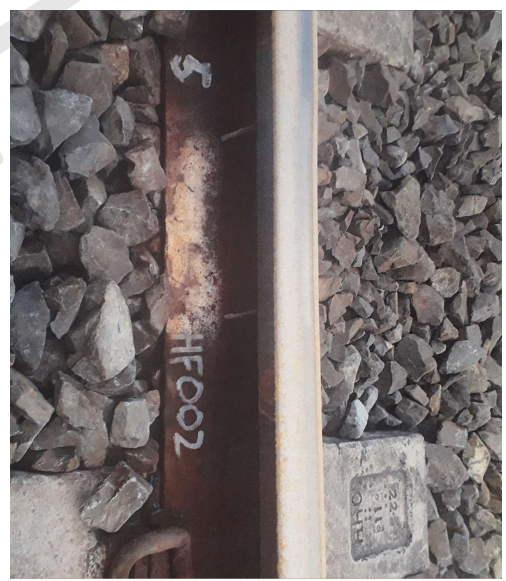
After

Assessed Condition Code 1

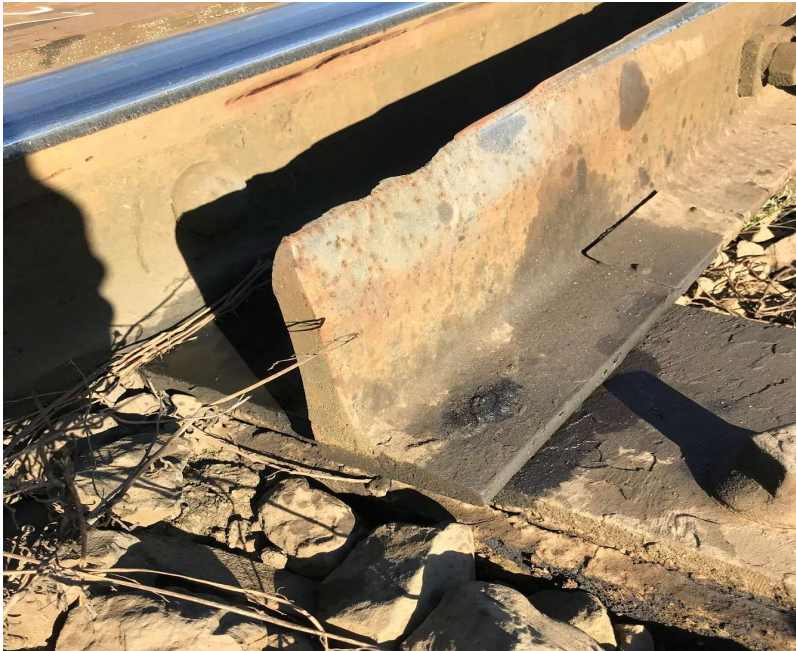
Typical Switch Rail welding

Before
Assessed Condition Code 4

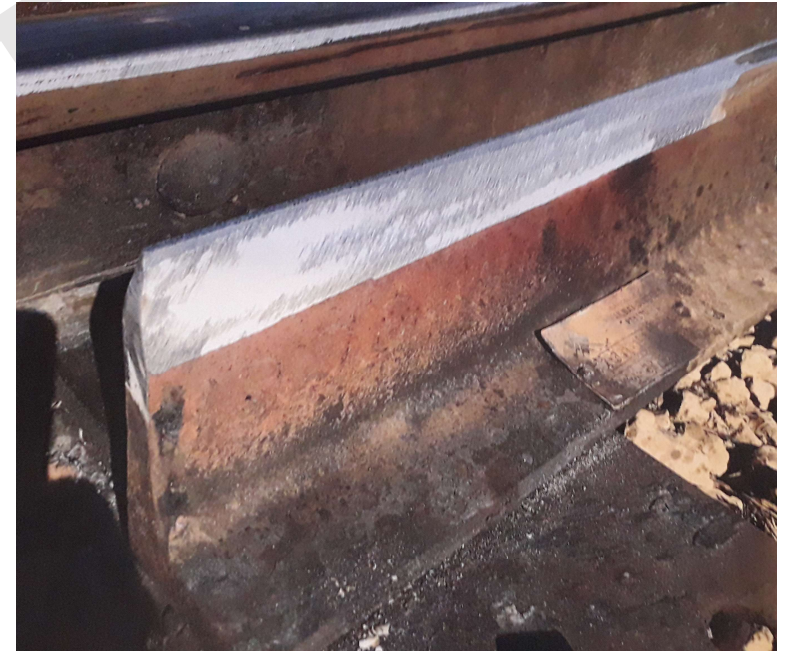
After
Assessed Condition Code 1

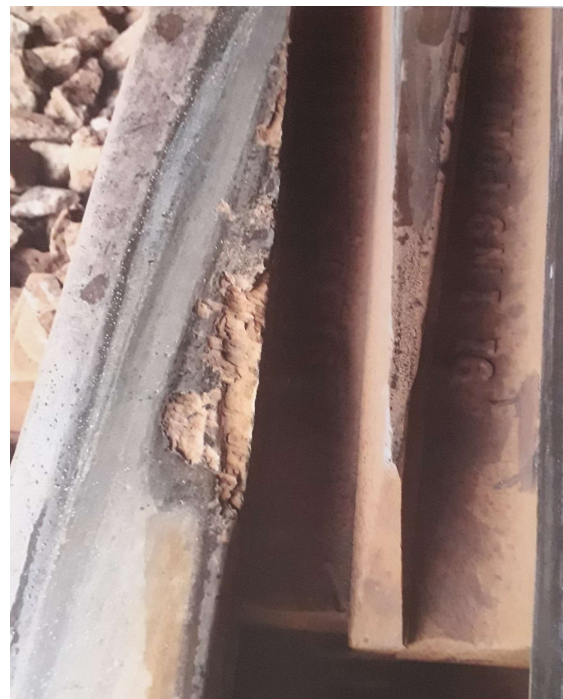
Before

Typical Frog Rail head repair

Assessed Condition Code 5

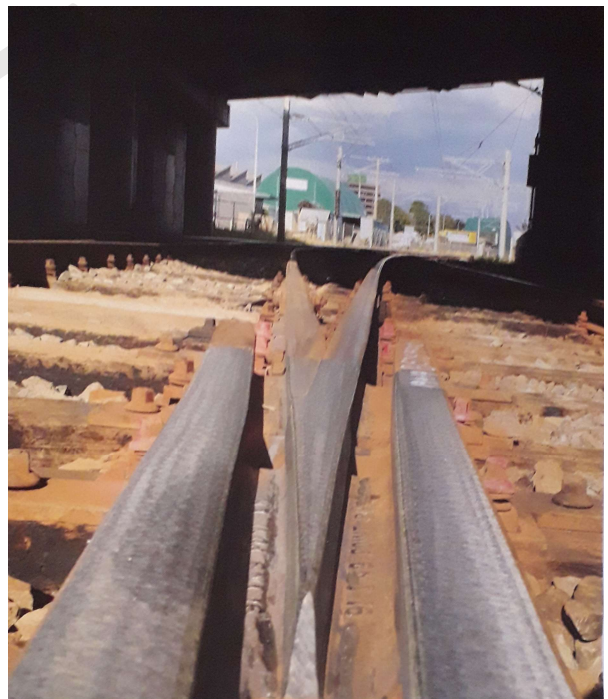
After

Assessed Condition Code 1

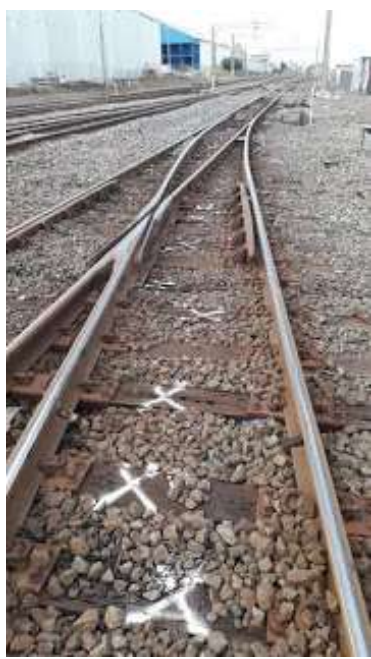
Before

Replacement of Peruvian Decayed Sleepers with Composite Sleepers - Westfield Turnout no. 1566

Assessed Condition Code 5

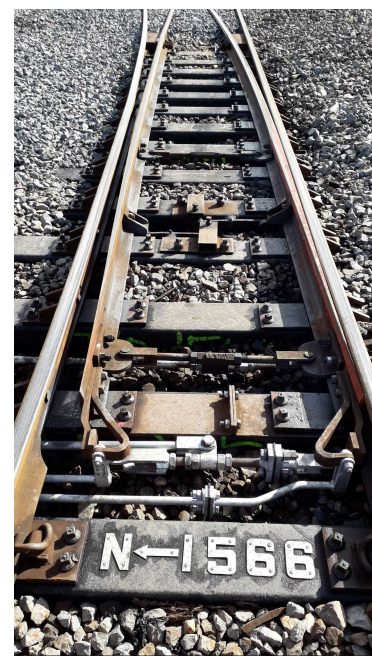
After

Assessed Condition Code 1

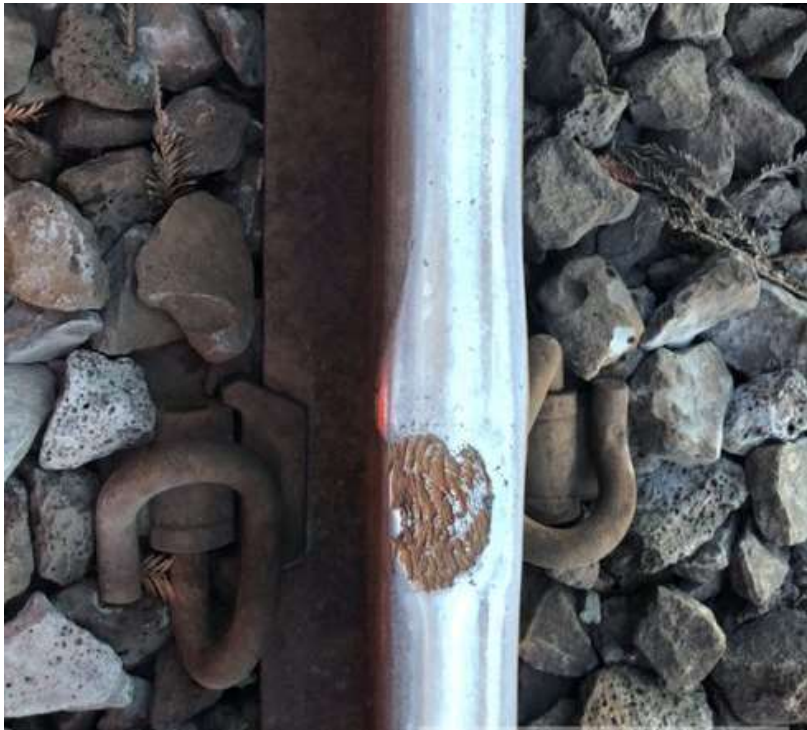
Before

Rerailing at Pukekohe to remove squats and RCF sections

Assessed Condition Code 4

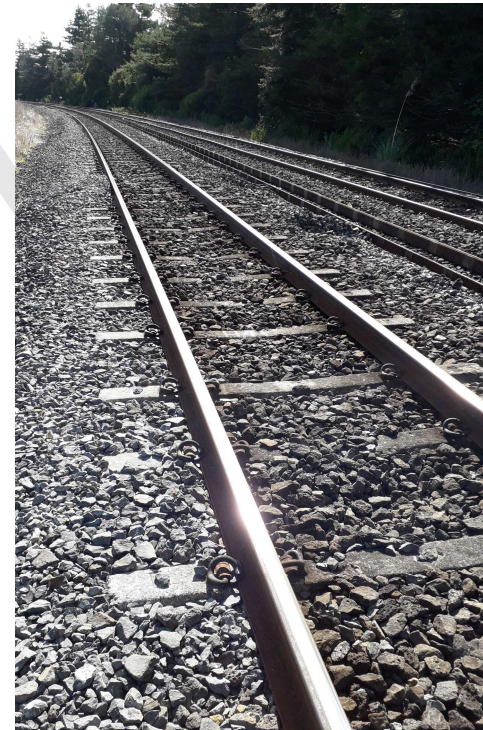
After

Assessed Condition Code 1
