AUCKLAND RAIL NETWORK HIGH LEVEL INFRASTRUCTURE REVIEW

Interim Findings and Assurance Report

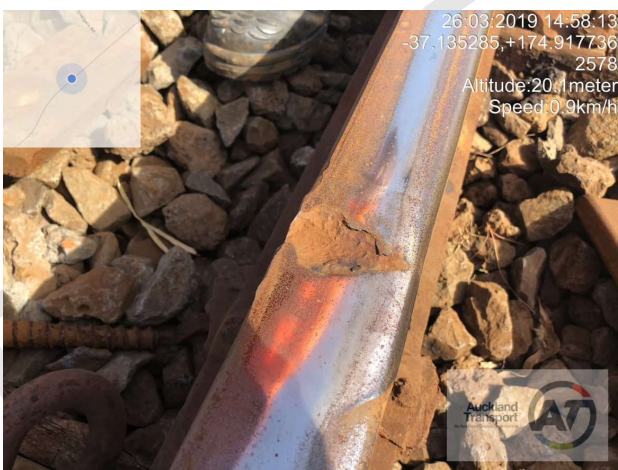
Work Order Details - CM **Status: RTP** **Discipline: TRACK**
3645750 **M125 - Remove faulty weld on UM NIMT 637.600km, right rail**

Based on Permanent Way Asset Condition Assessment Guide (Track Standard: T-ST-IN-5108) and Rail Management (Track Standard: T-ST-AM-5330), Timber sleeper condition, is condition level 3.

Long Description
 - Replace with 6.3m closure

Inspected regularly (weekly).

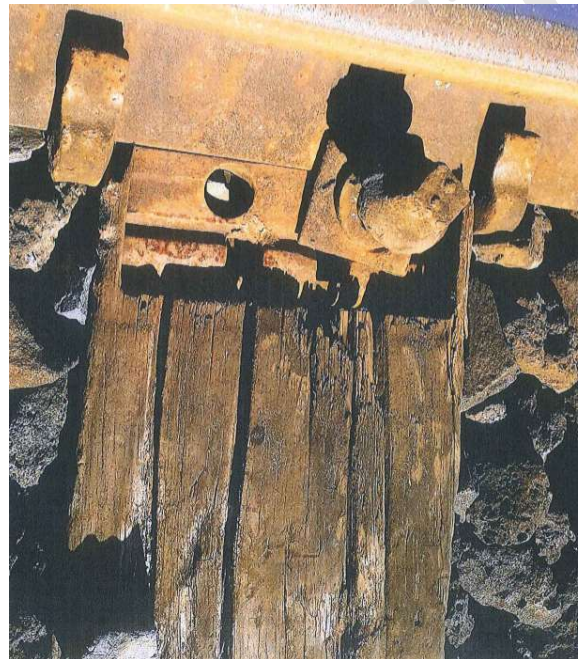
Replace T/O 19A NIMT

Based on Permanent Way Asset Condition Assessment Guide (Track Standard : T-ST-IN-5108) and Rail Management (Track Standard: T-ST-AM-5330), Switch point wear, is condition level 4.

Turnout to be replaced in FY20.

Inspected regularly.

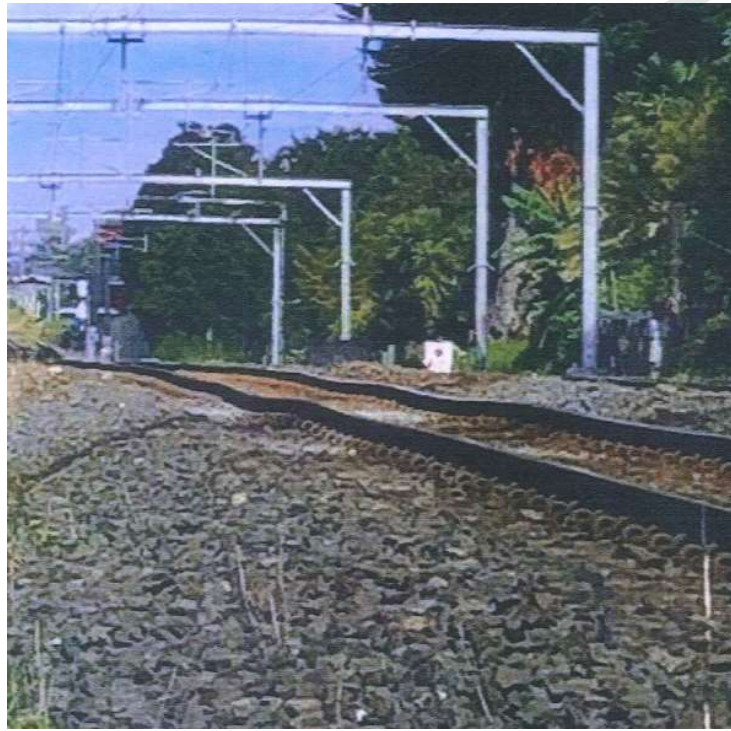
Remove mud spot NIMT

Work Order Details - AMREN **Status: CREATE** **Discipline: TRACK**
3718409 **M125 - NIMT DM, Mudspot forming 8 sleepers long at 662.769km**

PAR
mud spot has been reviewed and brought forward for repair into FY2019 during June BOL

The formation repair will be carried out in June, 2019.

Inspected regularly (weekly).

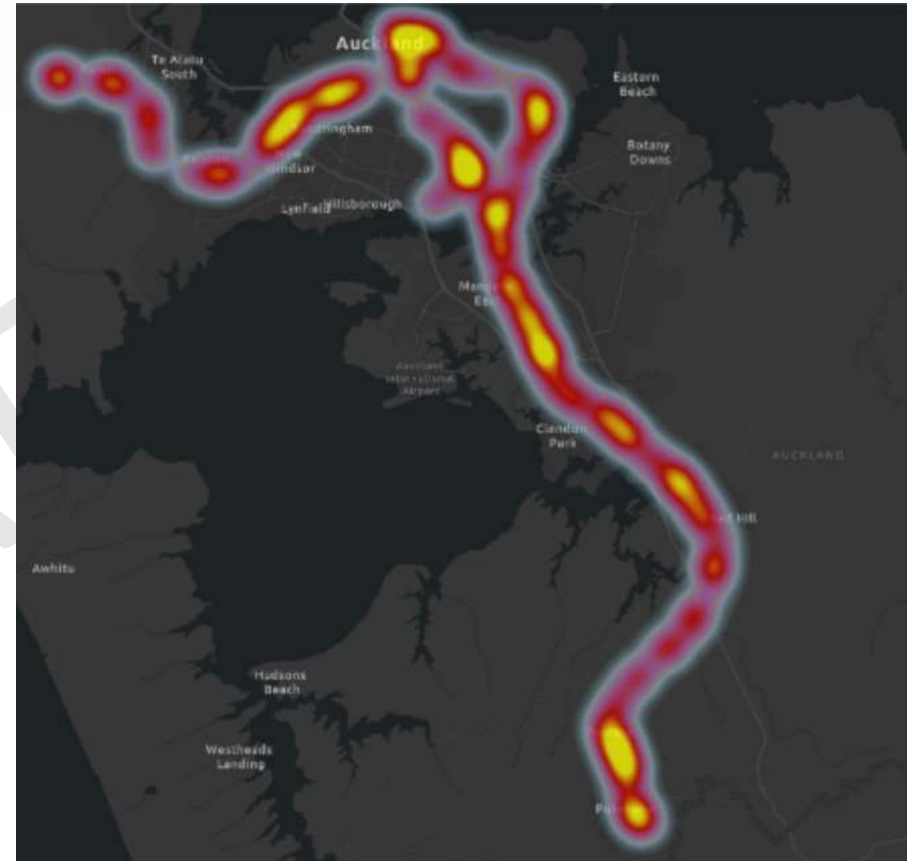
Heat map showing the location of faults that resulted in track speed restrictions (TSR)

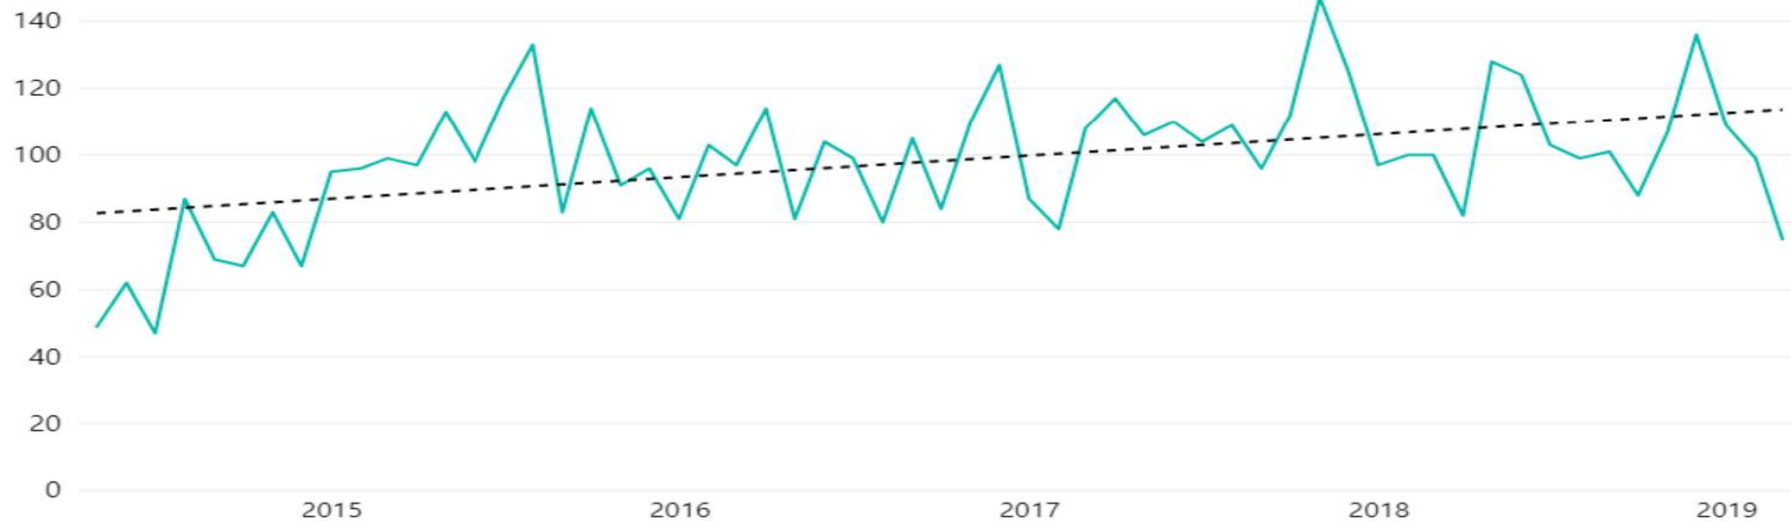
Number of 155 Faults Occurring per Month with Priority 1

These faults are the highest priority and must be inspected within 1 hour of being raised. This data shows a gradual increase in the number of faults raised since the EMU service began. During 2015 the rate of increase was steep with an approximate doubling of faults over the year. From 2016 the rate of increase in the number of faults has reduced and is rising at a less steep rate. Further analysis is required to determine the main reasons for the M155 faults and how they may be mitigated.

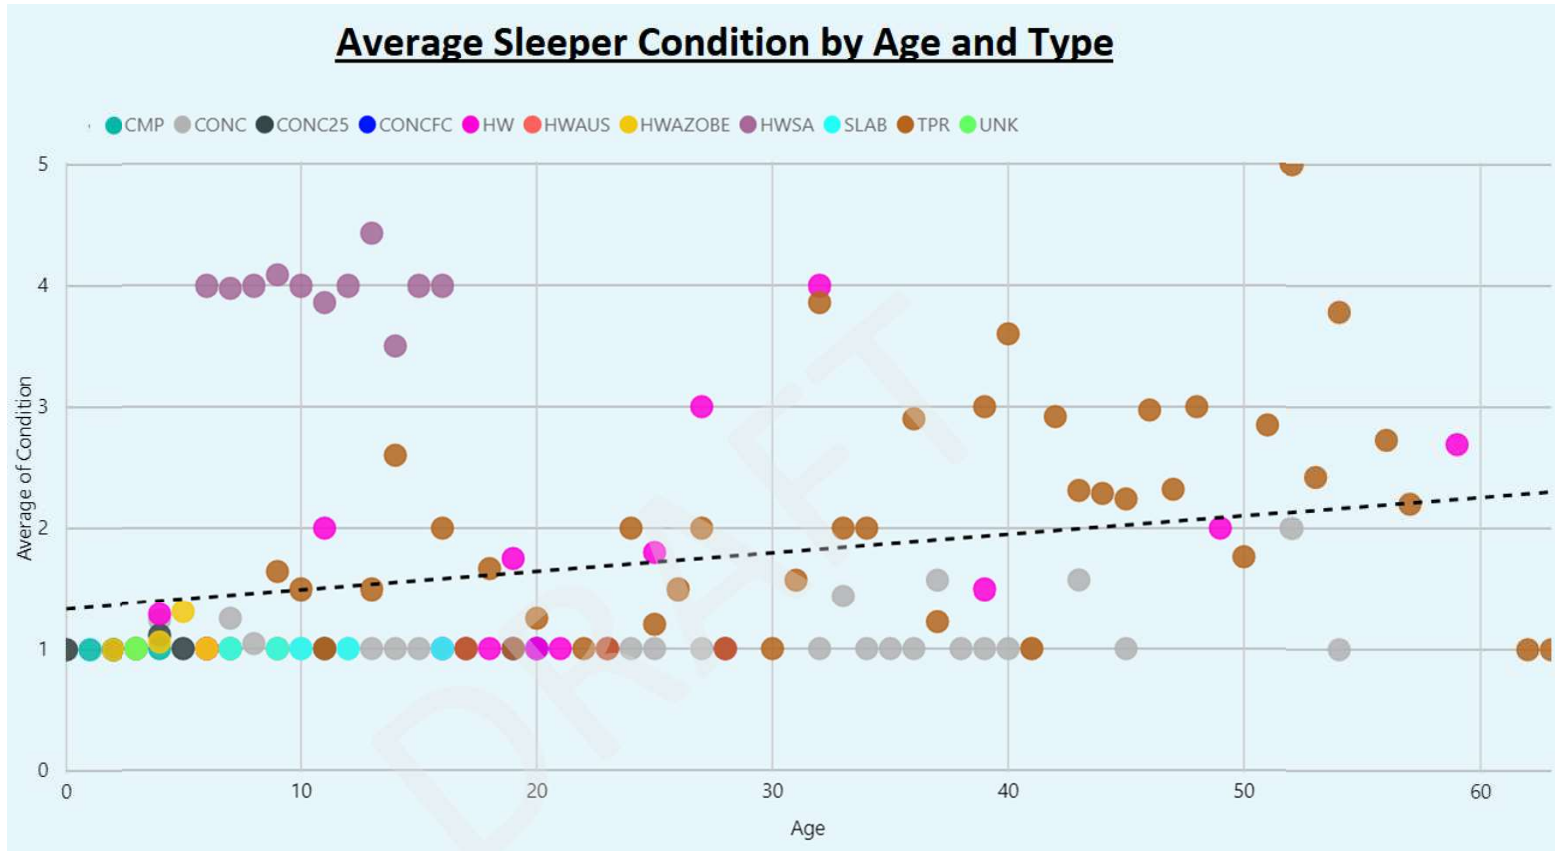
ANALYSIS OF SLEEPER CONDITION BY AGE AND TYPE

Condition is graded 1 to 5 (1 being best), HWSA sleepers around condition 4 with an age between 5 and 15 years are Hardwood South American Sleepers (Peruvian Decayed Sleepers). A programme of replacement is in place to remove all of the HWSA sleepers.
